Nathan Bryant

It seems fairly common on these cars for the A/C clutch plate to wear down to the point where the A/C compressor no longer is able to reliably turn itself on. When the problem starts to show itself, cooling will stop during warm weather after running for a while. At the start, turning the A/C off for a few minutes and then back on will make the symptoms go away. As the problem gets worse, the A/C may only work for the first 5 - 10 minutes of a trip and then it will quit working until the car has had time to cool down. Hot weather, stop and go driving, and quick acceleration all seem to make the problem worse.

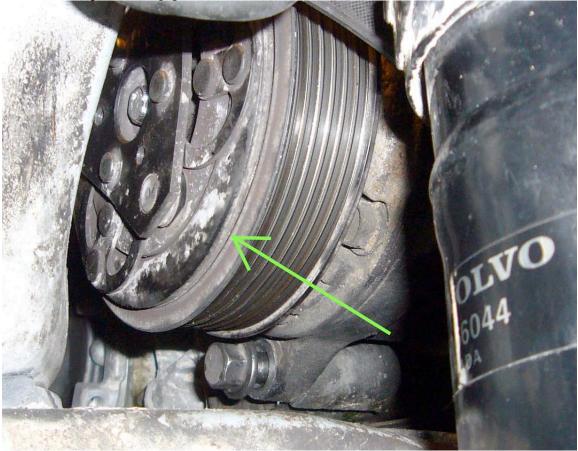
The A/C clutch gap can be checked underneath the car using a set of feeler gauges. The figure below shows where to check. The original specification for the gap is $\sim 0.3 - 0.4$ mm, depending on which message board you chose to believe. When the gap gets to around 0.8 mm, the clutch may not be able to re-engage after the compressor gets hot. The fix is to remove the clutch plate from the compressor, and remove enough of the shims in it to get the air gap back to ~ 0.4 mm.

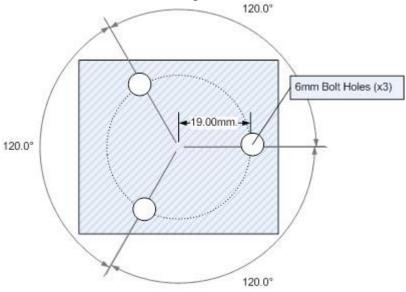
You will need some sort of a puller to remove the clutch plate from the pulley. You can construct one from an old front brake pad fairly easily. You will need 3 30mm M5 bolts and 1 30mm M6 bolt or stud. The following figure shows the pattern to drill into the piece of metal you will use as your puller (drill 3 8mm (5/16") holes at 120 degree angles off a 19mm radius circle). Remember that you can get the 120 degree angles by drawing a circle, placing the fixed end of the compass on the circle and drawing arcs (using the same radius) that intersect the circle. The arcs will be 120 degrees from each other and 60 from the fixed end of the compass.

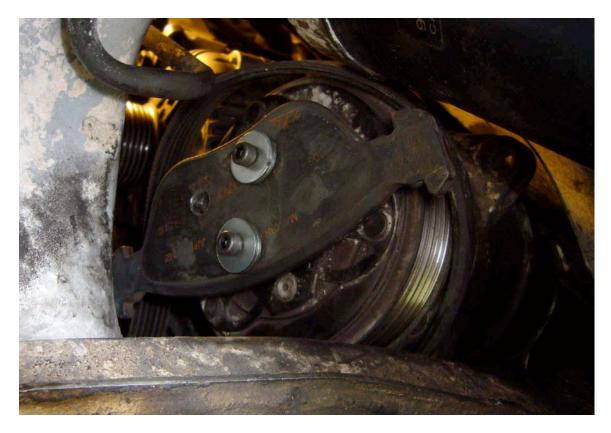
To pull the clutch plate, thread the M6 bolt into the center hole a few turns and attach the puller to the to the plate using the 3 M5 bolts through the holes you drilled. Figure x shows the puller plate attached. Finger tighten the bolts until the bottom of the puller plate rests against the top of the M6 bolt in the center of the compressor and then use a wrench to equally tighten the M5 bolts.

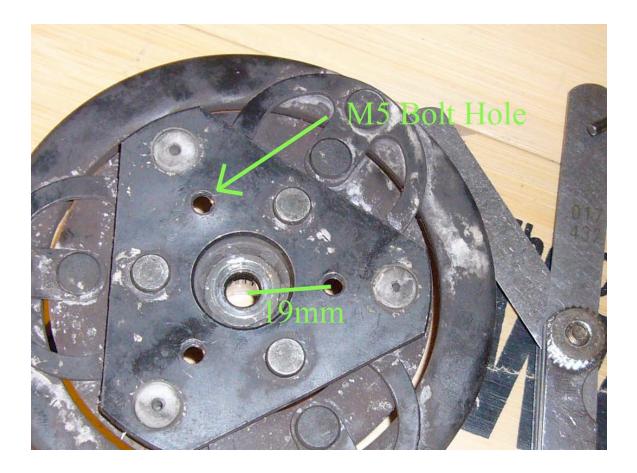
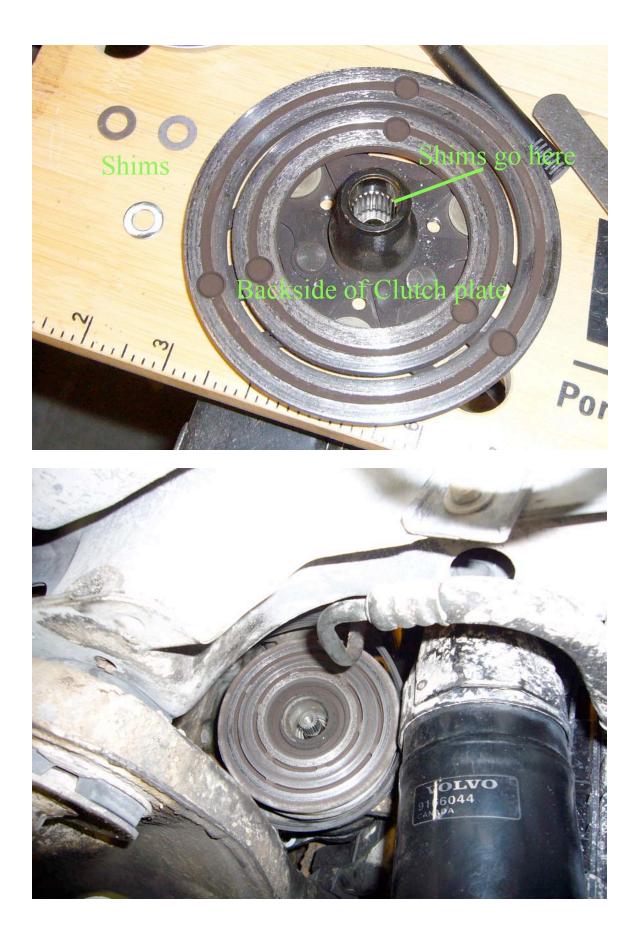
Once the clutch plate is off, you will find 3 shims in the hole the pulley mounting shaft goes into. The shims are different sizes (~0.1 mm, ~0.3mm and ~0.9mm). Remove appropriate shims to get the gap back down to 0.4 mm based on your original measurement of the gap. You can use an oil stone (knife honing block) to thin the 0.9mm shim if you need to remove more that 0.4mm.

Reattach the clutch plate and put everything back together, and you're done. Go for a nice long drive to test it out.
